Investigation of Construction Failure of Harbour Cay Condominium in Cocoa Beach, Florida

September 1981

H. W. Lew
N. J. Carino
S. G. Fattal
M. E. Batts

The investigation of the collapse of a five-story reinforced concrete flat-plate structure under construction at Cocoa Beach, Florida is presented in this report. The investigation included onsite inspection, laboratory tests and analytical studies.

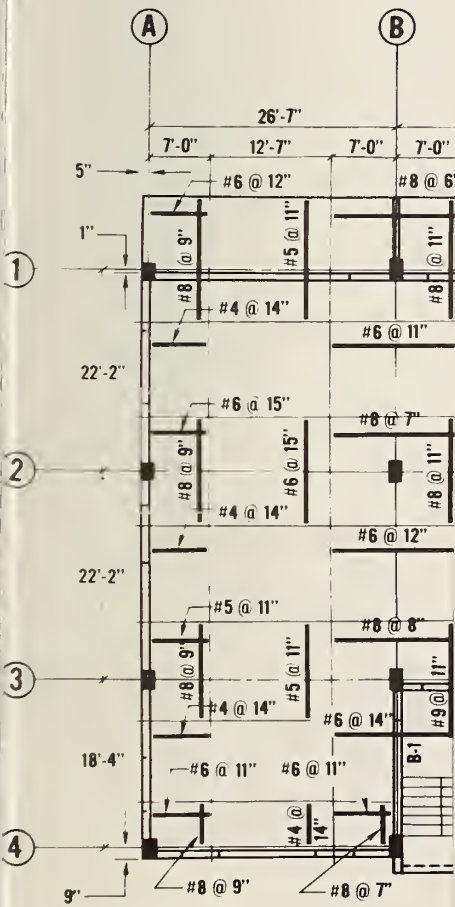
INDIVIDUAL HIGH CHAIR (4 1/4")

From the same sources, the quantities and sizes of individual high chairs (IHC) supplied for the top steel in a floor slab were identified as follows: 500 - 5-3/4" IHC, 470 - 4-1/4" IHC, 70 - 5" IHC, 50 - 4" IHC and 70 - 3-1/4" IHC. In addition, #5 support bars were supplied for use with the high chairs in the middle strip to support the one-way top reinforcement in these strips (fig. 2.1). The specified spacing of high chairs was 4 ft (1.2 m) on center. With the aid of the framing plan for top bars in the slab (fig. 2.1), and quantities of chairs of various specified sizes supplied, it was determined that the 5-3/4-in (146-mm) high chairs were used for the one-way top reinforcement in the middle strips and the 4-1/4-in (108-mm) high chairs were used for the two-way top reinforcement in the column strips. Figure 2.3 shows the top reinforcement layout in a column strip assuming bars in both directions have the same diameter D. The relationship between chair height, bar diameter, effective depth, cover, and slab thickness are illustrated in the same figure.

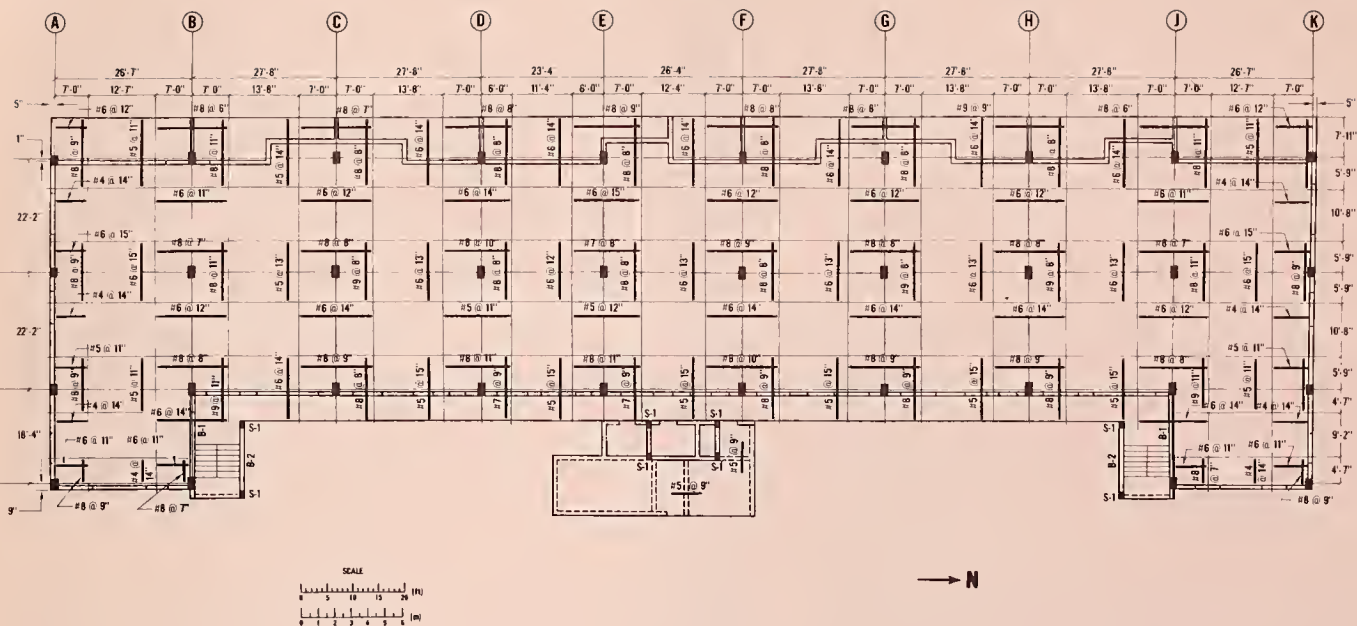
Figure 2.1 Top reinforcement layout in typical floor slab

The building was a five-story flat plate structure intended for residential use. A typical framing plan for the second through fifth floors is shown in figure 2.1. The columns were 10 x 18 in (254 x 457 mm) in cross section with the following exceptions: the columns on lines A and K were 10 x 12 in (254 x 305 mm) and those at the exterior ends of the stairwells were 8 x 12 in (203 x 305 mm) in cross section. The thickness of the floor slabs was 8 in (203 mm). The thickness of the balcony slab along the west side varied from 7-1/4 in (184 mm) at the column line to 6-1/2 in (165 mm) at the edge. The thickness of the walkway slab along the east side (as scaled from the structural plans) was 7-1/2 in (191 mm). The first story floor slab was cast on grade. The elevator tower was structurally detached from the building. Top of slab story heights were 8'-8" (2.64 m). At the foundation level, the columns were supported by pile caps containing two to nine piles each. The exterior caps were connected by continuous wall footings.

Reinforcing steel for the slabs and columns was specified as deformed bars ASTM Grade 60. The framing plans in figures 2.1 and 2.2 show the top and bottom reinforcement in the slab, respectively. Table 2.1 shows the reinforcing schedule for the columns. The structural drawings called for 4000 psi (27.60 MPa) strength for concrete in the above-grade portion of the structure. The specified live loads were 20, 40, 60 and 100 psf (960, 1920, 2870 and 4790 Pa) for the roof, floor, public balcony and stairways, respectively. The wind design was specified to conform with the SBCC Standard Building Code, 110 mph (49 m/s) wind with a 100-year return period [2.2]. Concrete block masonry strength was specified as $f_m = 1500$ psi (10.35 MPa). Non-load bearing concrete masonry construction was used for the exterior walls of the building.

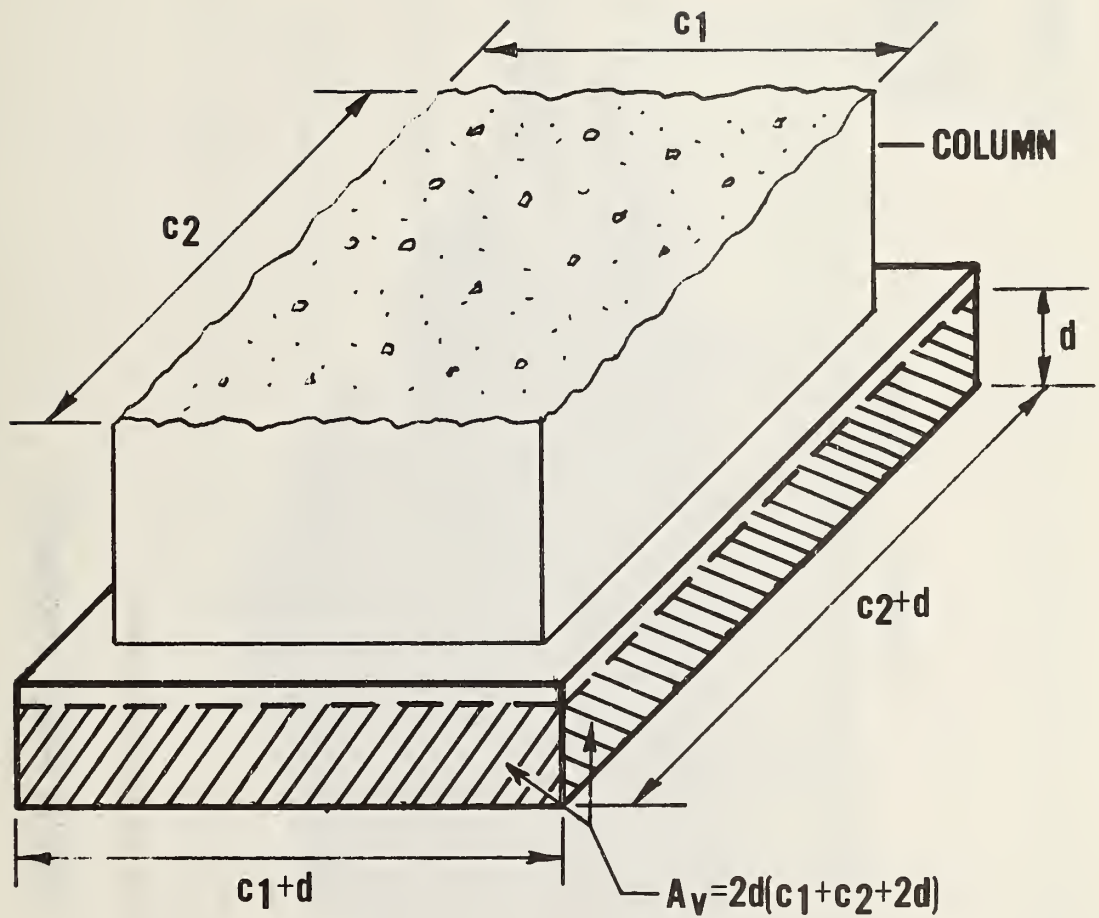
Figure 2.6 Area of critical section for punching shear

The importance placed on actual chair heights and their location is due to the fact that the effective depth of the slab is a critical parameter governing its punching shear and bending capacity. Figure 2.6 defines the critical shear area used in calculations of punching shear stresses in the slab at the periphery of a column. The punching shear area depends on the sectional dimensions c_1 and c_2 of the column and the effective depth, d , which appears in all three dimensions defining this area.

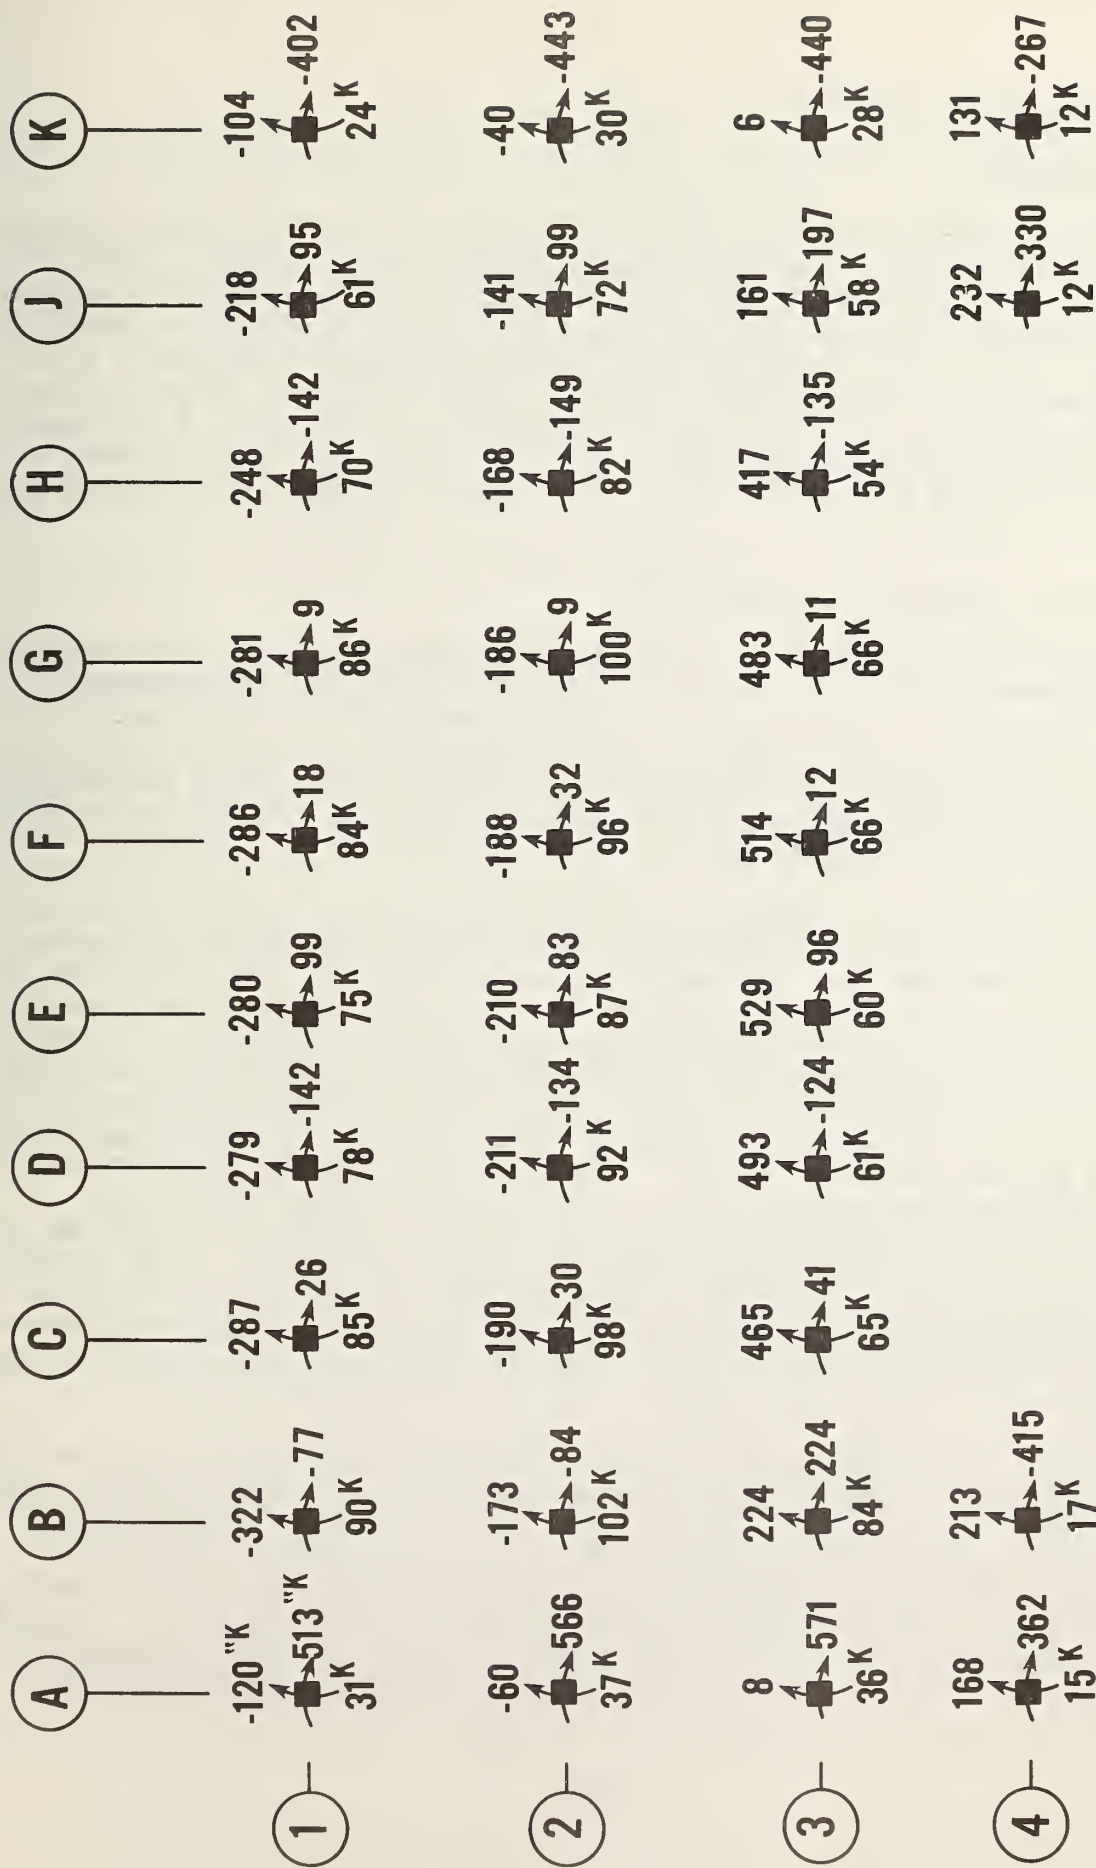
Figure 5.13 Fifth floor punching shear and column moments

- 4) In order to account for the three-dimensional response of the shored structure, the finite element method was used for the final analysis.
- 5) The results of the analysis indicate that the most heavily loaded slab-column connections are in the fifth floor at columns B-2 and G-2.

To verify that such a failure had occurred, punching shear stresses resulting from direct shear forces and unbalanced moments were computed at slab-column connections using the shear and moment values for construction loads given in figure 5.13. These shear stress values were compared with the shear capacity of the slab based on the predicted in-place strength of concrete at the time of collapse. Because the punching shear stress values are maximum at the fifth floor level (see figures 5.12 and 5.13), the shear stresses are evaluated only for this level. The guidelines given in the ACI Code [2.1] are followed in computing the punching shear stress. Figure 6.1(a) shows the critical section in the slab around an interior column. The critical section where shear stresses are evaluated is taken perpendicular to the plane of the slab and a distance a half of the effective depth away from the periphery of the column. The assumed distribution of shear stresses at the critical section is shown in figure 6.1(b). The critical sections for edge and corner columns and corresponding assumed shear stress distributions at these critical sections are shown in figure 6.2(a) and (b) and figure 6.3(a) and (b), respectively.

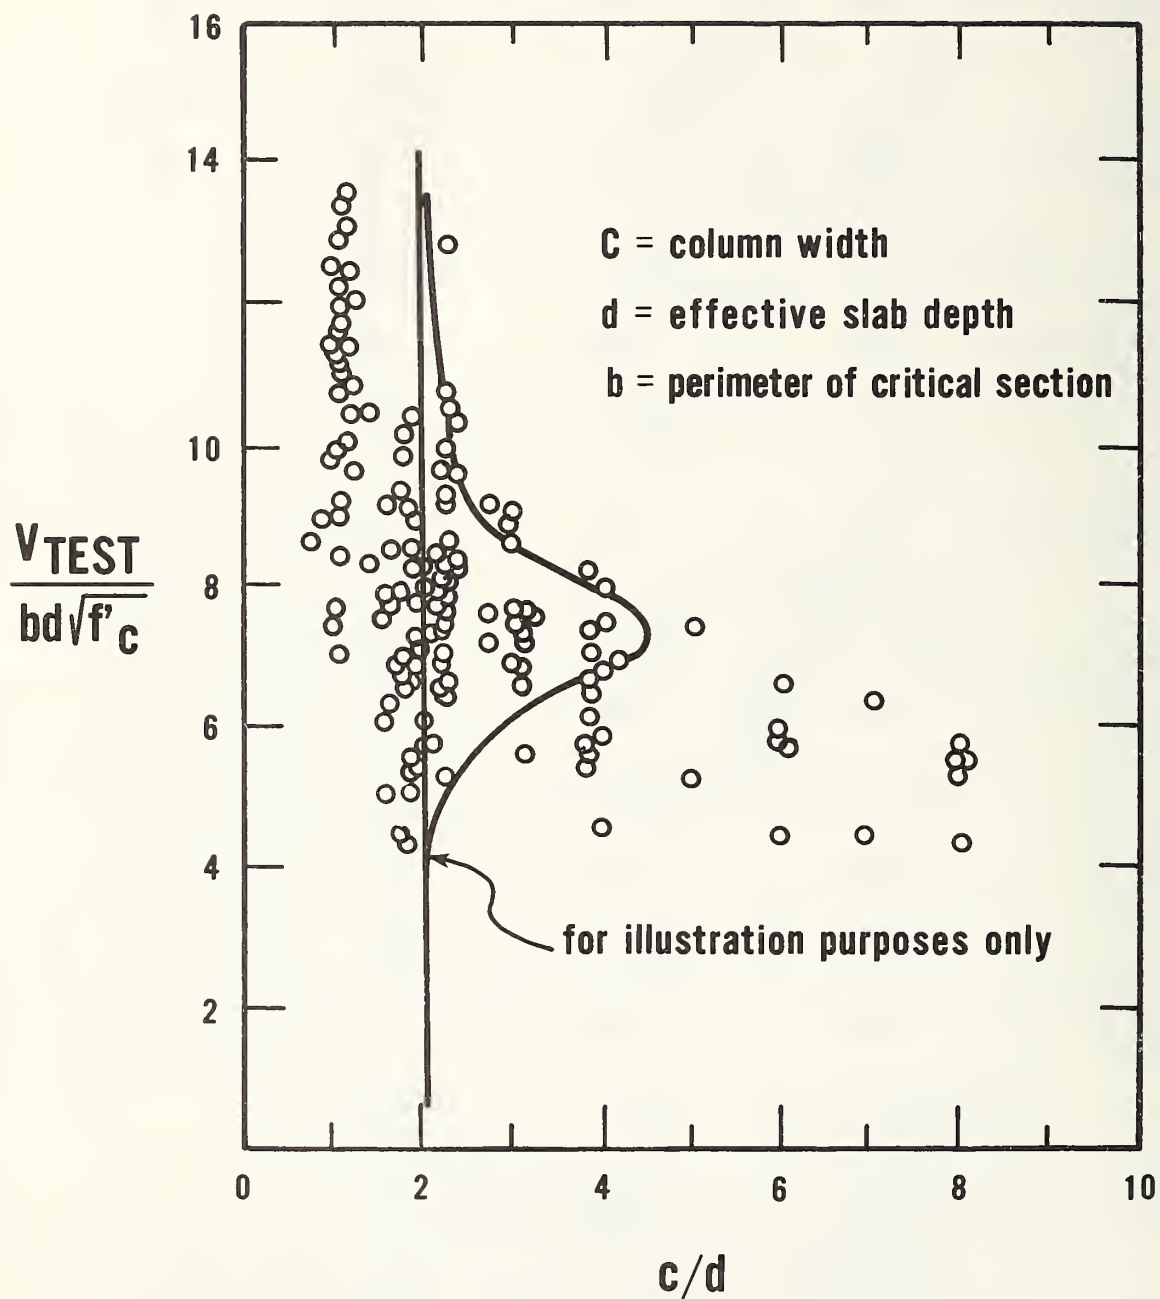
Figure 6.5 Results of punching shear tests of slab-column connections (ref. 6.1)

If, for the sake of illustration, the probability of failure at any given location where a stress of $4\sqrt{f'_c}$ occurs is assumed to be two percent ($P_1 = .02$), which is quite plausible in light of the data shown in figure 6.5, the probability of failure, P_2 , of an element in a system consisting of 30 such locations would be (assuming independence)

It should be pointed out that the data shown in figure 6.5 was obtained from laboratory experiments where, in general, much better quality control can be exercised than in the field. Therefore, it is reasonable to expect that if actual field conditions were simulated, the data would have shown greater scatter and a lower expected value than indicated in figure 6.5. Both factors imply a greater probability of strength below $4\sqrt{f'_c}$. There is evidence, as discussed in chapter 4, that the concrete used in the structure had high variability in terms of composition and strength.
